JOB NAME	LORDSFIELD SWIMMING CLUB
JOB No.	7483
	OVERTON SWIMMING POOL – STRUCTUAL ASSESSMENT
	January 2023

REPORT

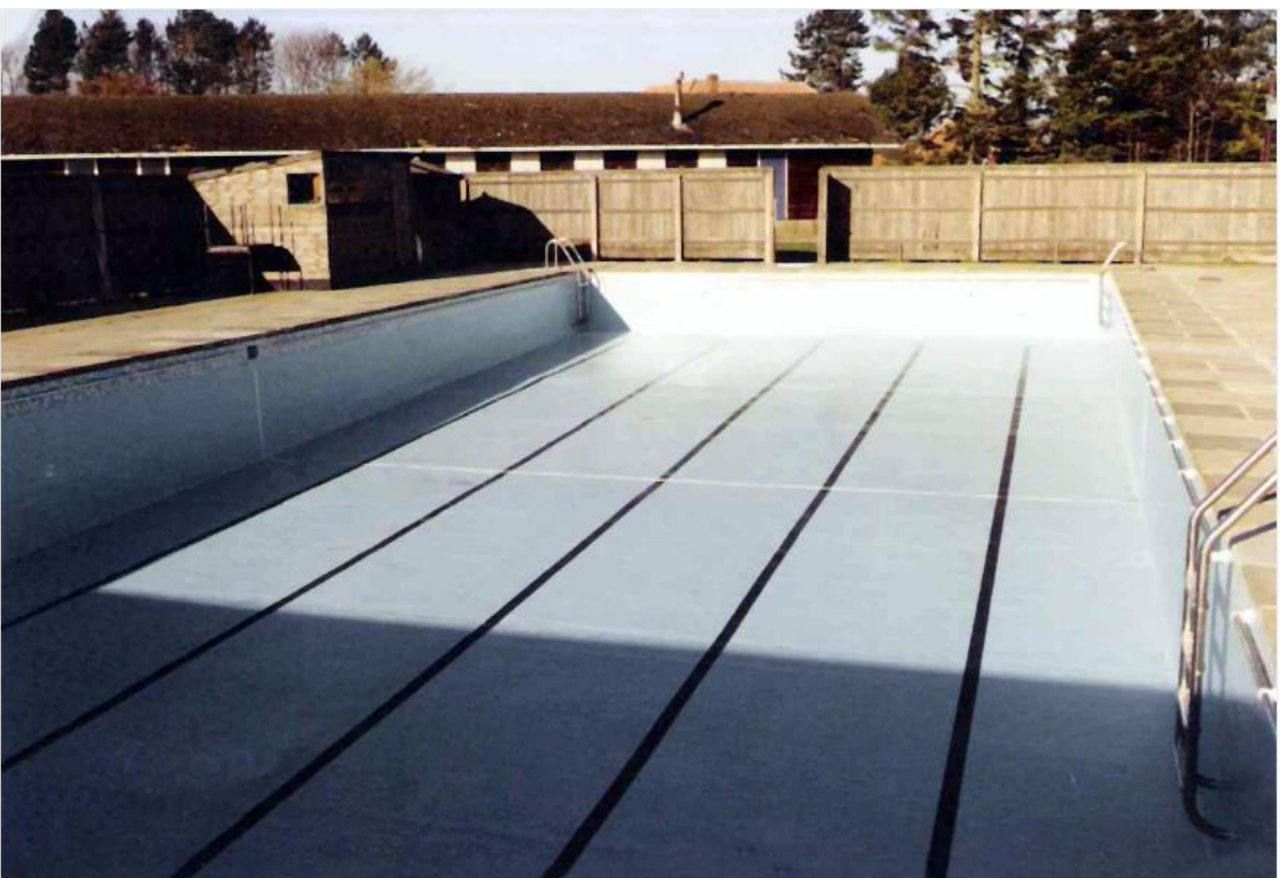
New Pool Lining 1987

Photo 3: Historical photo 1987 New pool lining. For more historical photo refer to Galley & Pool Historical in link <http://www.overtonswim.org.uk/community/lordsfield-swimming-club-6047/home/>

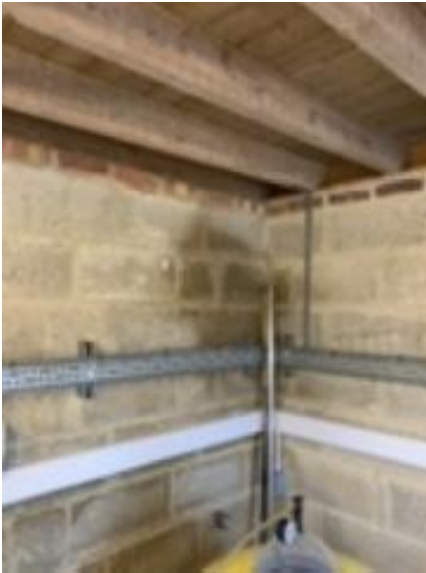
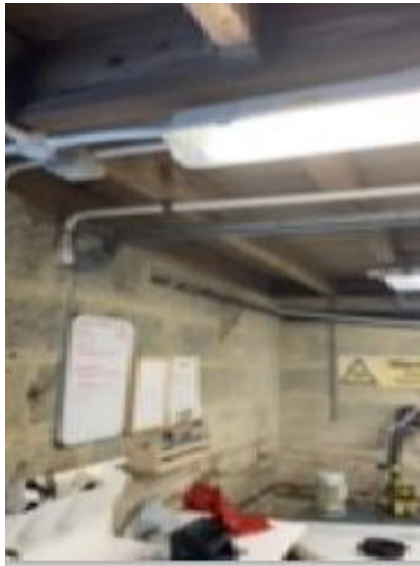
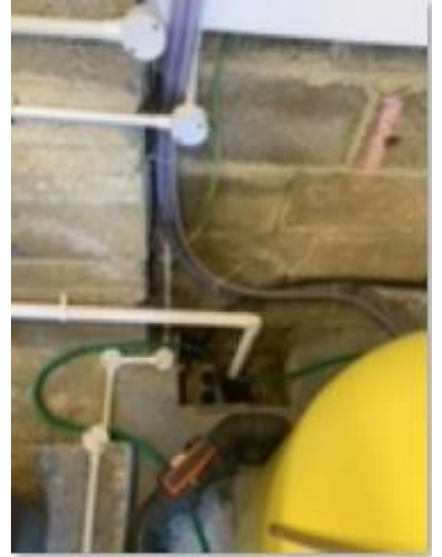
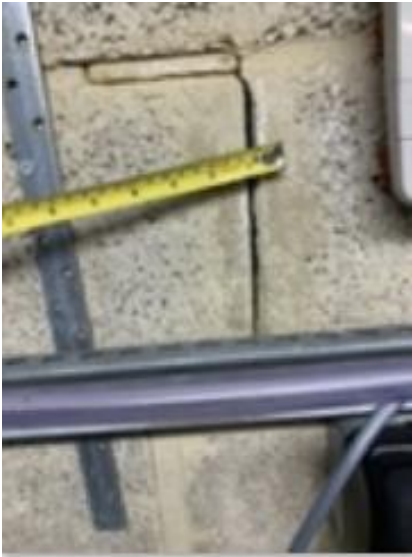
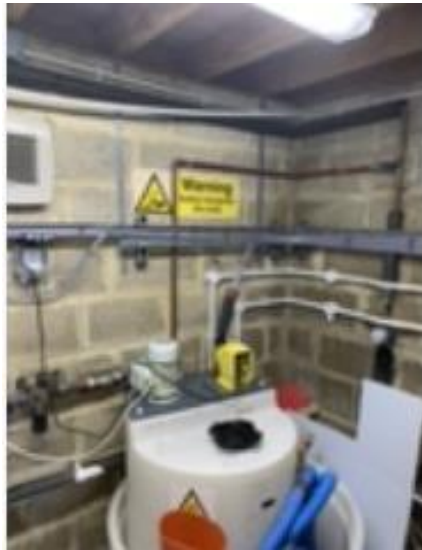
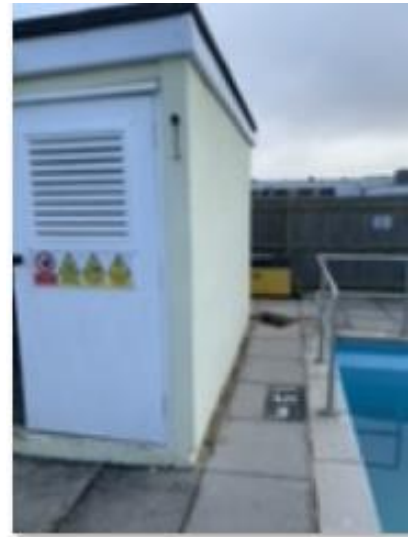
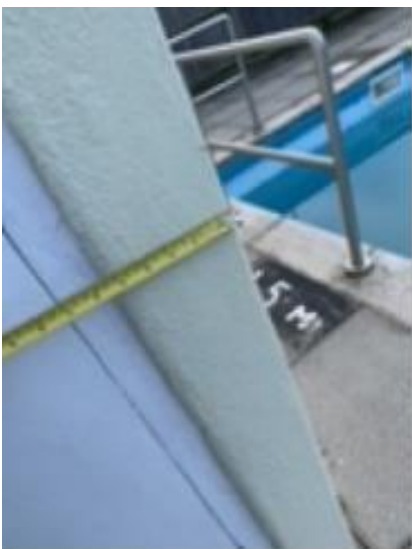
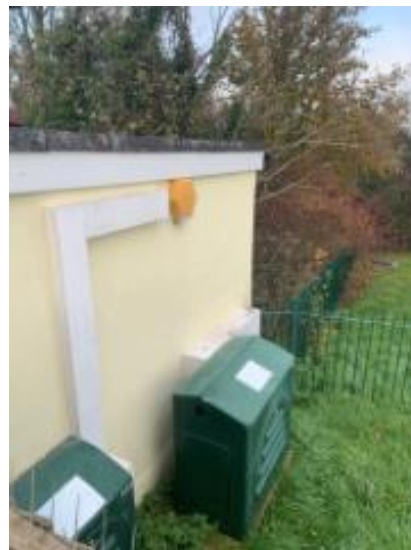
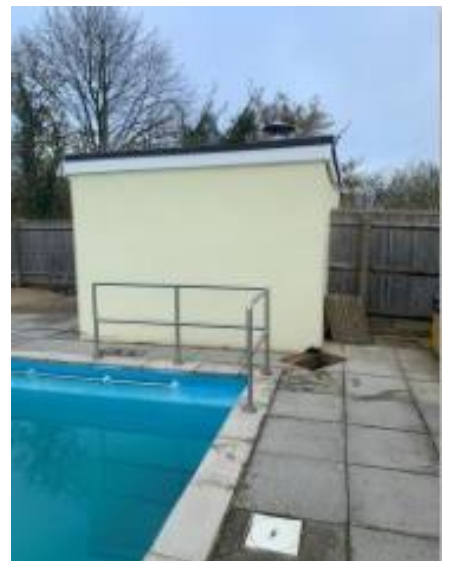
Although the plant appears to be watertight and dry, there are signs of damp / moisture at various height of the block wall. The plant is also suffering from subsidence to one corner, with diagonal cracks as large as 6mm visible to the internal face of the walls corner. The damp to the wall appears to be a combination of rising damp, condensation, leaky plants and rainwater finding its way through the external render / single skin block wall. The concrete slab finish is uneven and roughly finished and shows signs of some cracks that could be due to ground movements.

The general arrangement of the plants and their condition is evident of a space that has gradually been changed as required to accommodate new plants as others have been decommissioned. To bring the plant room up to the current standard, the room's water tightness would need to be improved and the subsidence further investigated.

Photo 7: Site visit photos - Plantroom

- **Existing Plantroom** – The existing plantroom becomes redundant once the new one is built. The removal of the plantroom would also get rid of the pinch point of the circulation due to the current small gap between the plantroom and pools edge.
Recommendations: Demolish the existing plantroom and incorporate the space as part of the pool surround.

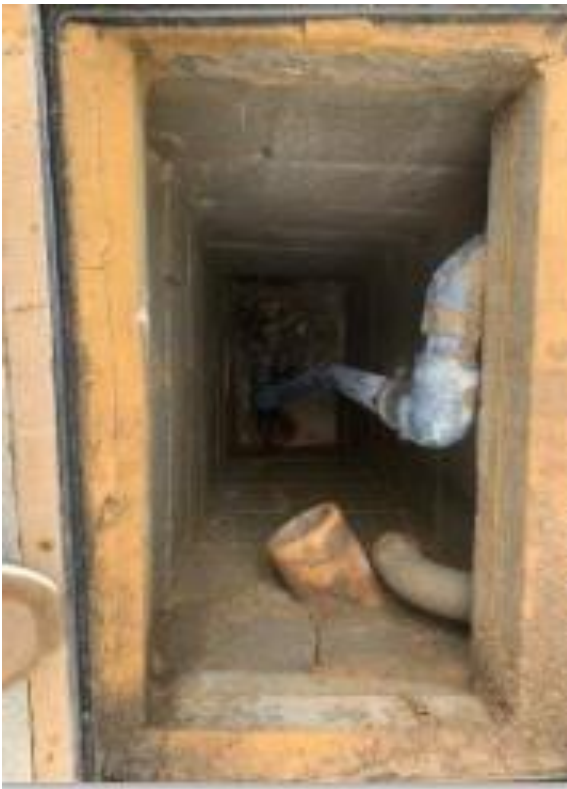
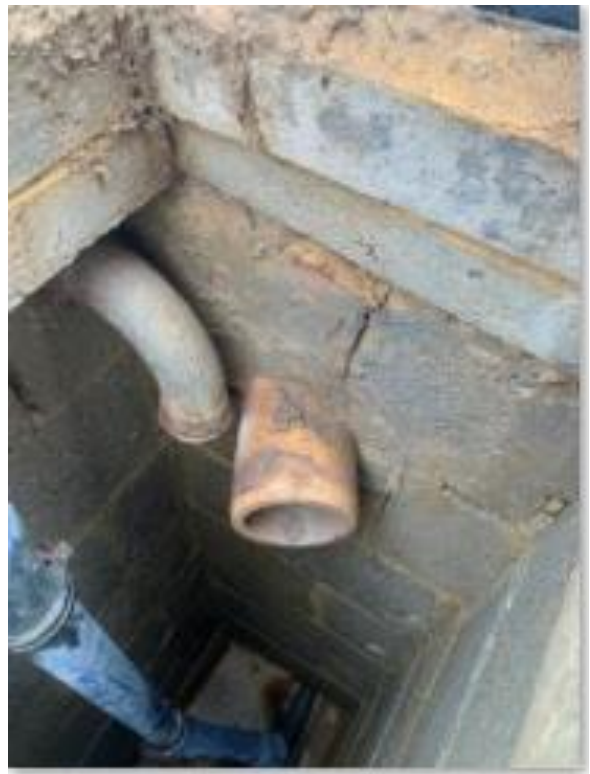
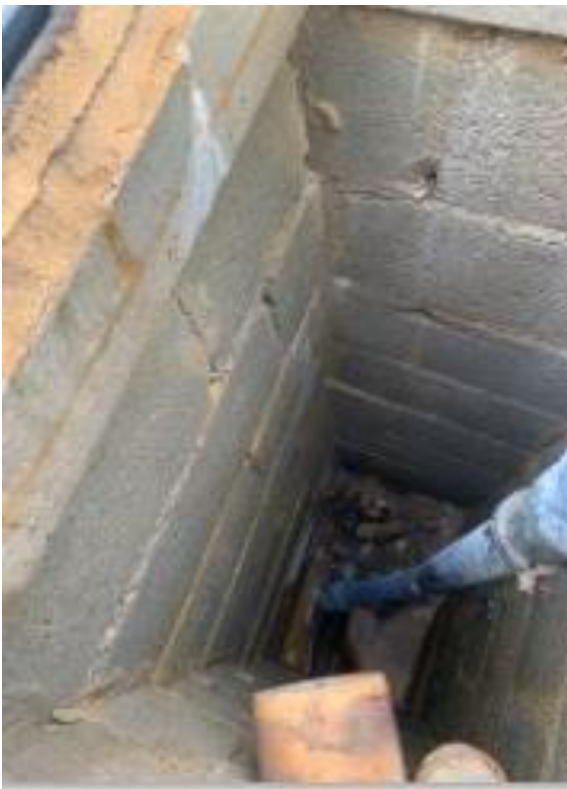
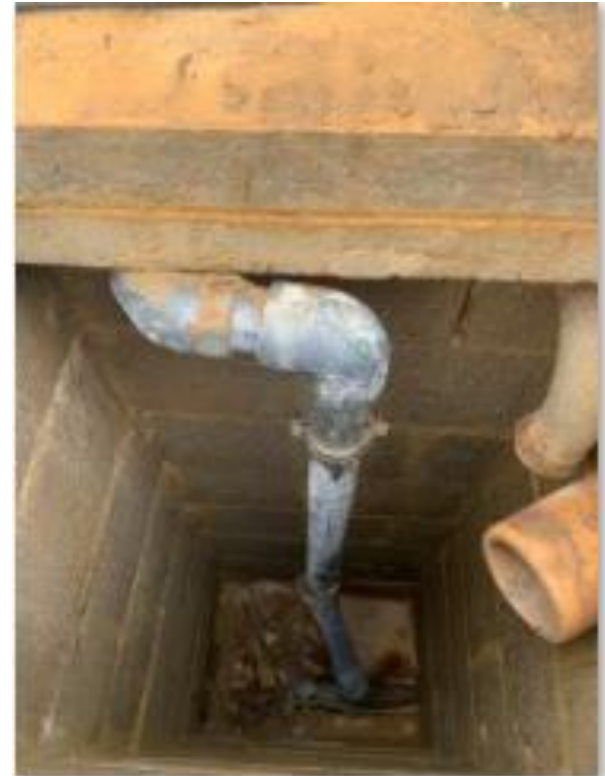
A manhole has been located at the pinch point between the pool and plantroom that is providing drainage for the plant room and the pool. The manhole chamber is 600x500 internal dimensions, 2020mm in depth to invert level. The chamber is unusually made of block walls rather than brick and is unlikely to have been part of the original built. It could be that the manhole was introduced at a later date as a new chamber or replaced an original manhole. A recently constructed chamber of this depth could be associated to the subsidence identified in the plant room as it is in close proximity of the manhole.

There is no evidence of blockages to the chamber, but there are some crack to the upper parts of the chamber. There is no safe means of access to the bottom of the chamber for future inspections or maintenance.

Photo 8: Site visit photos – Manhole photo next to Plantroom

- **Existing Manhole** – The manhole adjacent to the existing plantroom is suffering from some cracks to the walls and inadequate safe access provided for maintenance.
Recommendations: Carryout remedial works to repair high level cracks to the wall chambers and carryout assessment as the best safe access for maintenance of the chamber. A CCTV of the drainage would be necessary to confirm their condition and suitability for the proposed improvement works.

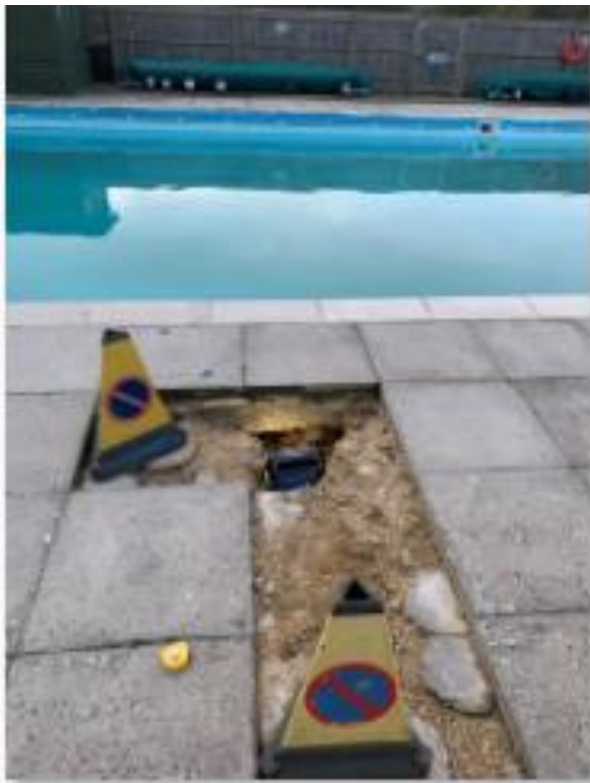
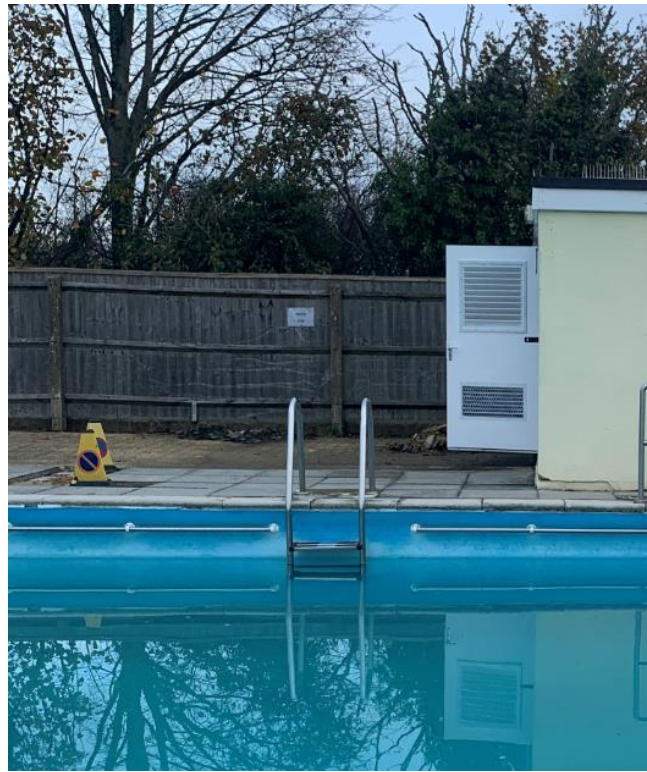
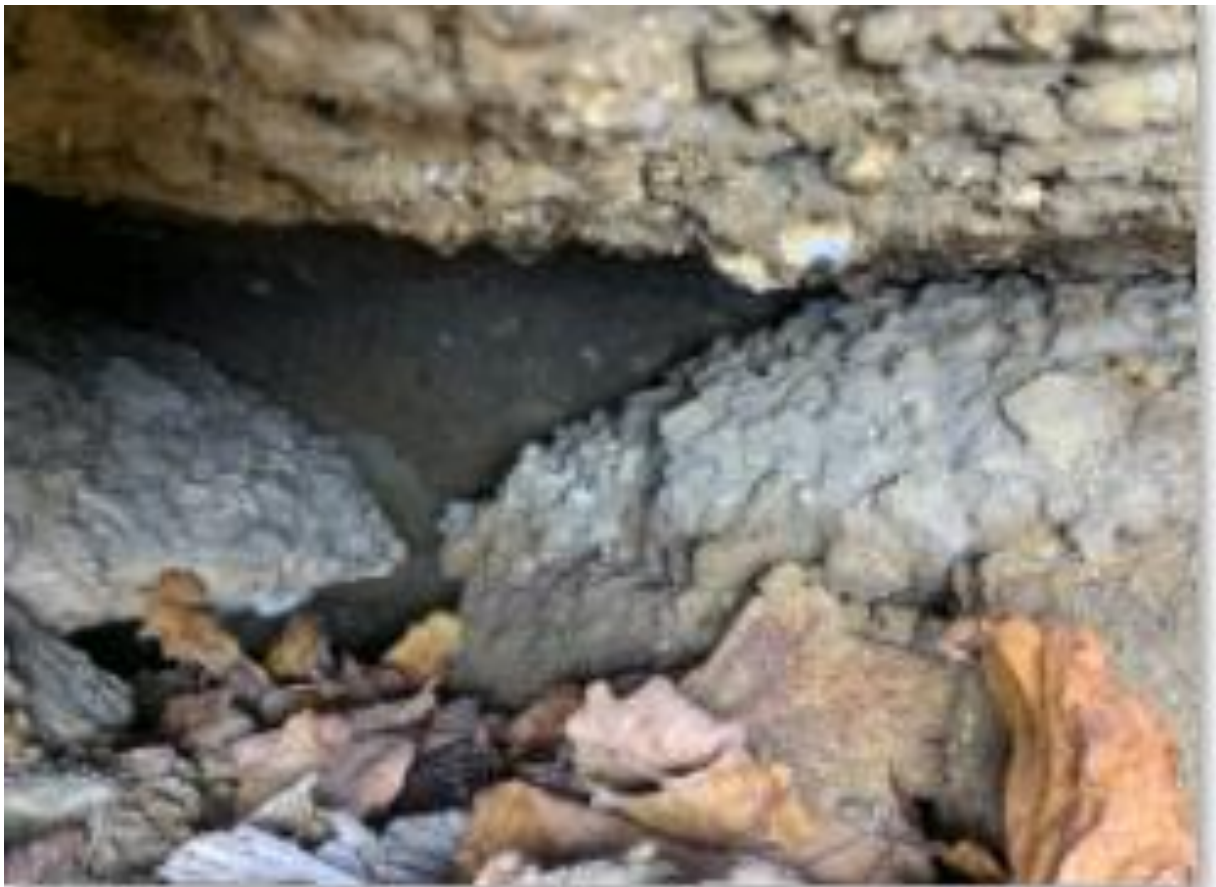
Although the pool lining covers the pool tank's structure, the back of the pool tank is visible at a location on the East side where a few surround paviours are removed, exposing the back of the tank's wall. As the concrete surface appears to be smooth, this could be taken as concrete built within formworks which is common for reinforced concrete structures. The wall is estimated to be 300mm thick based on approximate site measurements. The pool inlets and outlets are 350mm from the pools edge, approximately where the water level is. There is no evidence of any major defects to the pool tanks but considering the limited visibility of the water and being fully covered by an internal lining, there are little opportunity to confirm the tanks structural condition during the site visit.

The concrete paviours generally appear weathered and sloping away from the pools edge. They appear to be intact, other than on the East side of the pool where a few of the paviours have been removed to further investigate the reason they have become loose and uneven. The hardcore below these appear to have been washed away by perched water that has loosened the ground and formed voids below the paviours. The source of the perch water would need to be further investigated and is likely to be water leaking from the pool tank, leaks from below ground services or as there are no drain gullies, rainwater has gradually found a natural draining route through the hardcore below the paviours.

Photo 9: Site visit photos – location of paviers removed to investigate substrate. Back of pool tank visible

- **Pool Surround** – The pool surrounds pavements appear to be fine other than on the Eastern side where a number of pavements have been removed to investigate the condition of the substrate. It is not clear how rainwater currently drains and the concrete / timber decking finish are not suitable for a public space and would need to be replaced with nonslip pavements to match the existing.
Recommendations: Carryout investigation as to the suitability of the substrate local to where the pavements have been removed. The rain water appears to be soaking into the ground through the pavement joints. Using containment membrane and manging the water soaking through the pavement should be considered as part of the proposed improvement.

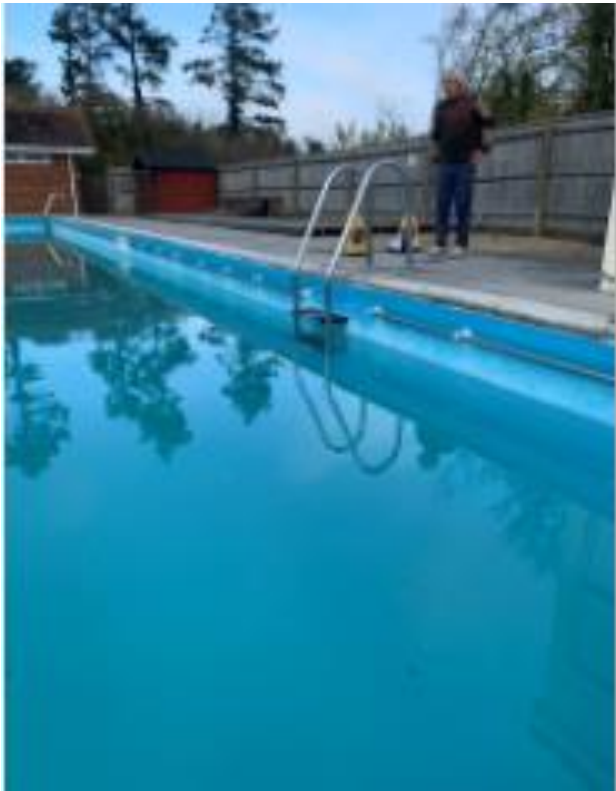
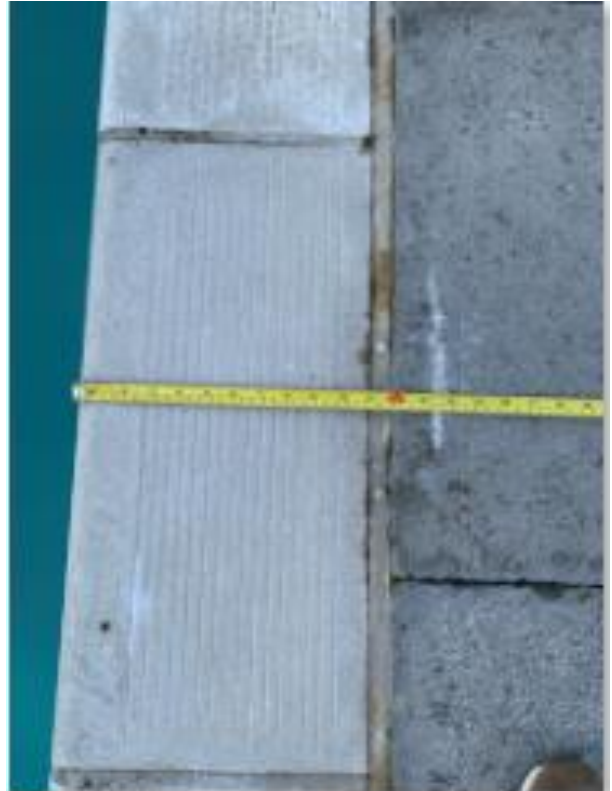
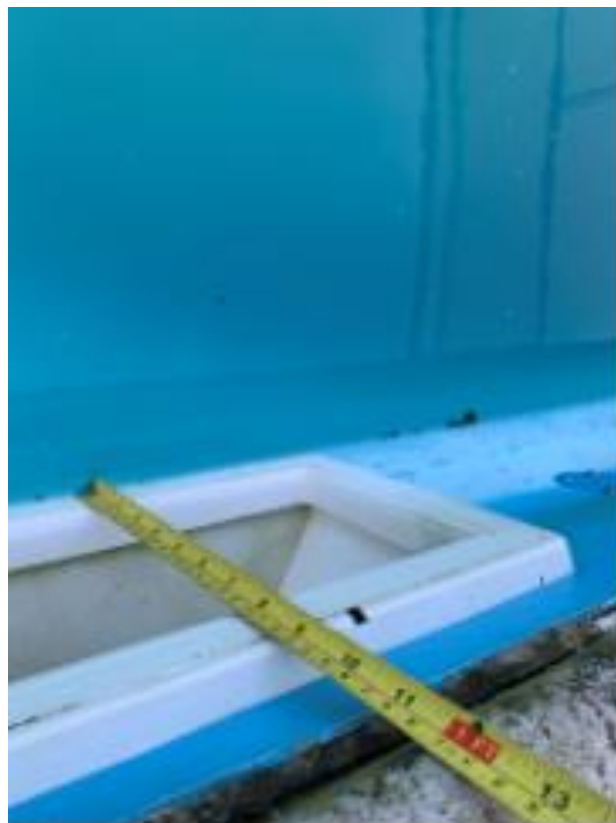
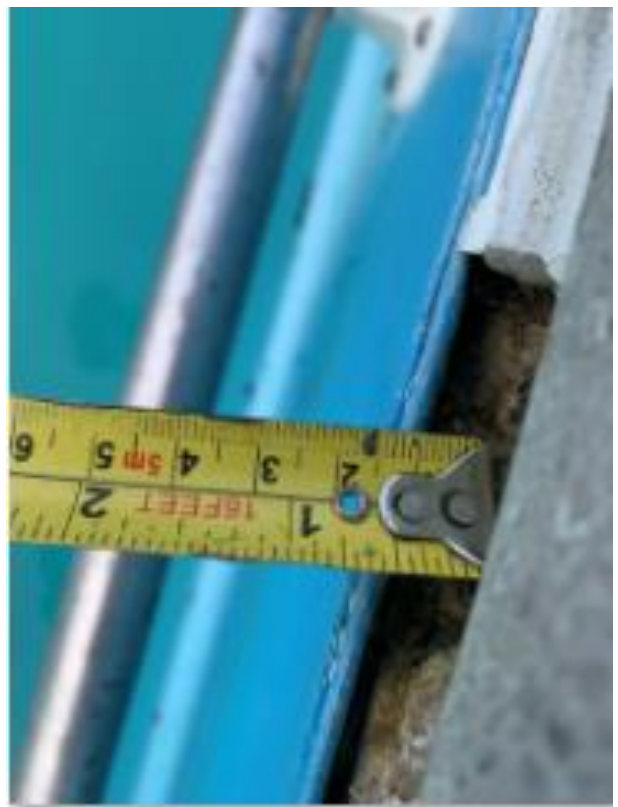
The coping stone to the edge of the pool appears to be intact with little visible defect other than staining that can be easily jet washed. There is no overlap between the pool lining and the coping stone which makes it an easy weak junction for the water to scape behind the lining when the pool is being used by swimmers.

Photo 10: Site visit photos – Examples of the pools edge and weak junction of the coping stone and lining

- **Pool Lining** – The existing pool lining appears to be passed its useful design life. The timing of replacing the lining would influence to the way the investigation works for assessing the tank's structure is carried out. Early change would provide us the opportunity to inspect the structure prior to committing to the improvement works. Whilst, if it is decided to keep the lining for much longer, investigation would be limited to the ground side of the pool tank.
Recommendations: Seek advice from a pool specialist as to the condition of the pool's lining. The advice should confirm whether the lining would need to be changed fully or can it remain for a period of time with specific repair and enhancement works. If the decision is to retain the lining for longer, detail of accommodating new service penetrations through the lining should also be established. Improvement of the existing lining detail with the pools edge coping stone would also need to be considered.
