JOB NAME	LORDSFIELD SWIMMING CLUB
JOB No.	7483
	OVERTON SWIMMING POOL – STRUCTUAL ASSESSMENT
	January 2023

REPORT

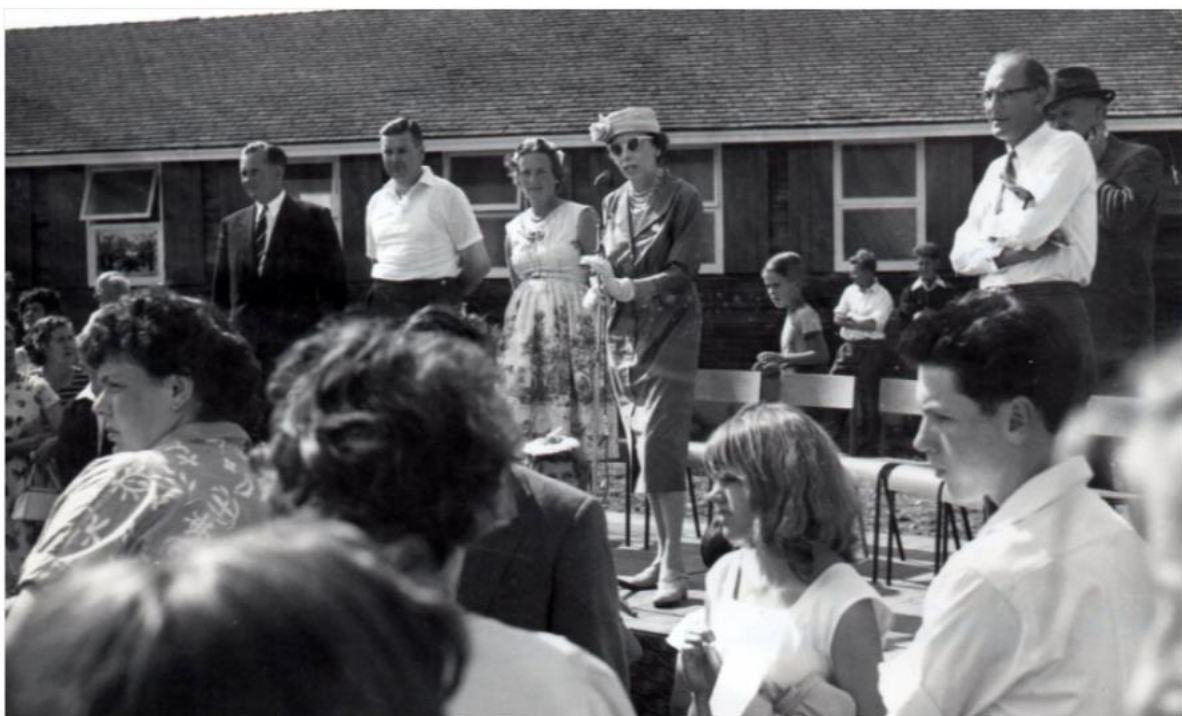
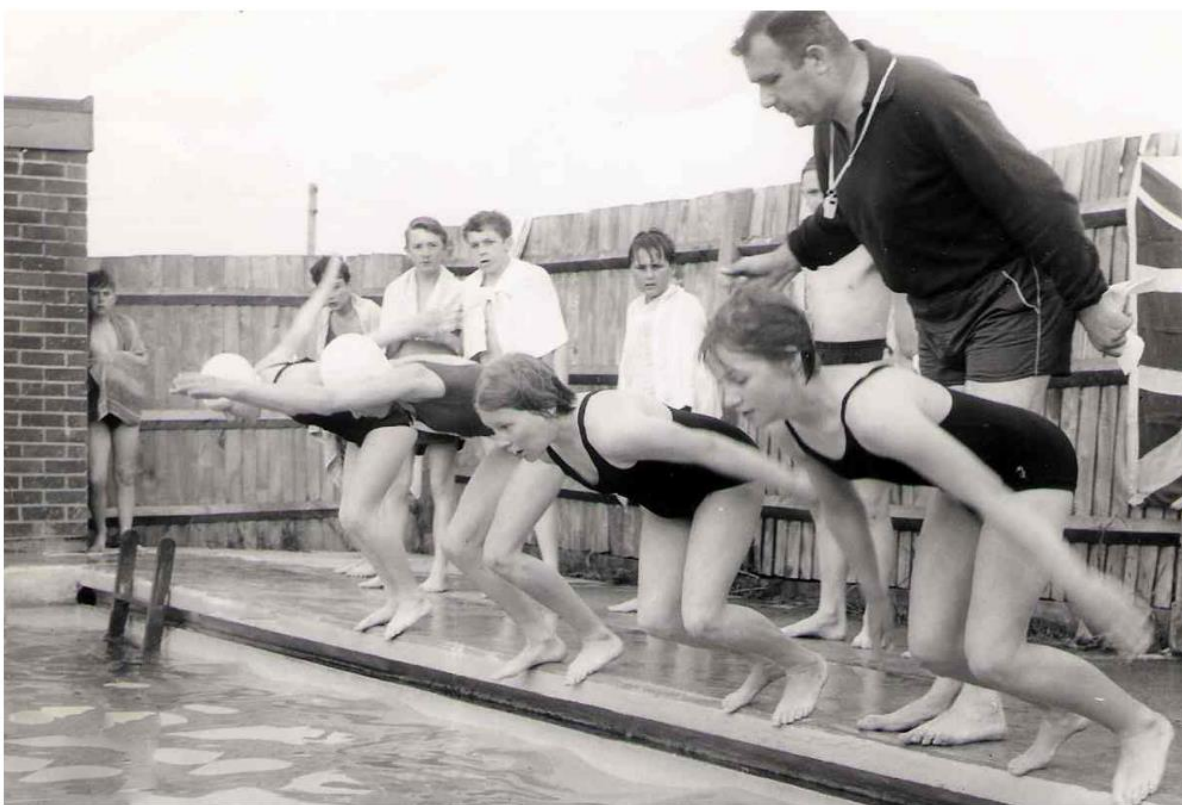
Photo 1: Historical photos 1959 opening ceremony and 1960's Swimming Club.
For more historical photo refer to Galley & Pool Historical in link
<http://www.overtonswim.org.uk/community/lordsfield-swimming-club-6047/home/>

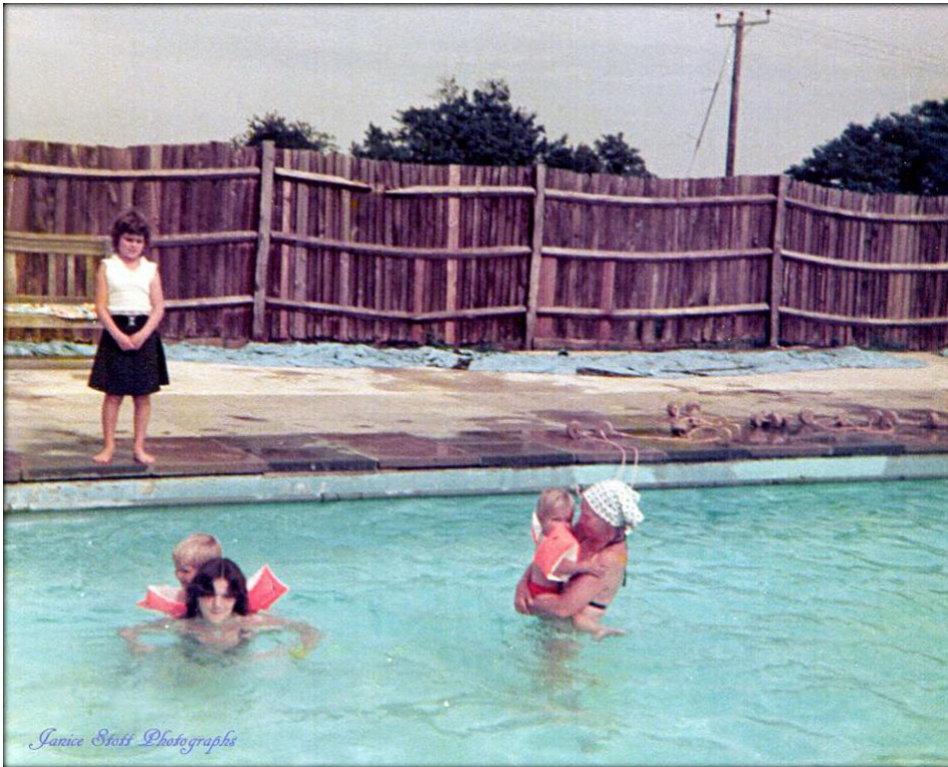
Photo 2: Historical photos 1970s. For more historical photo refer to Galley & Pool Historical in link <http://www.overtonswim.org.uk/community/lordsfield-swimming-club-6047/home/>

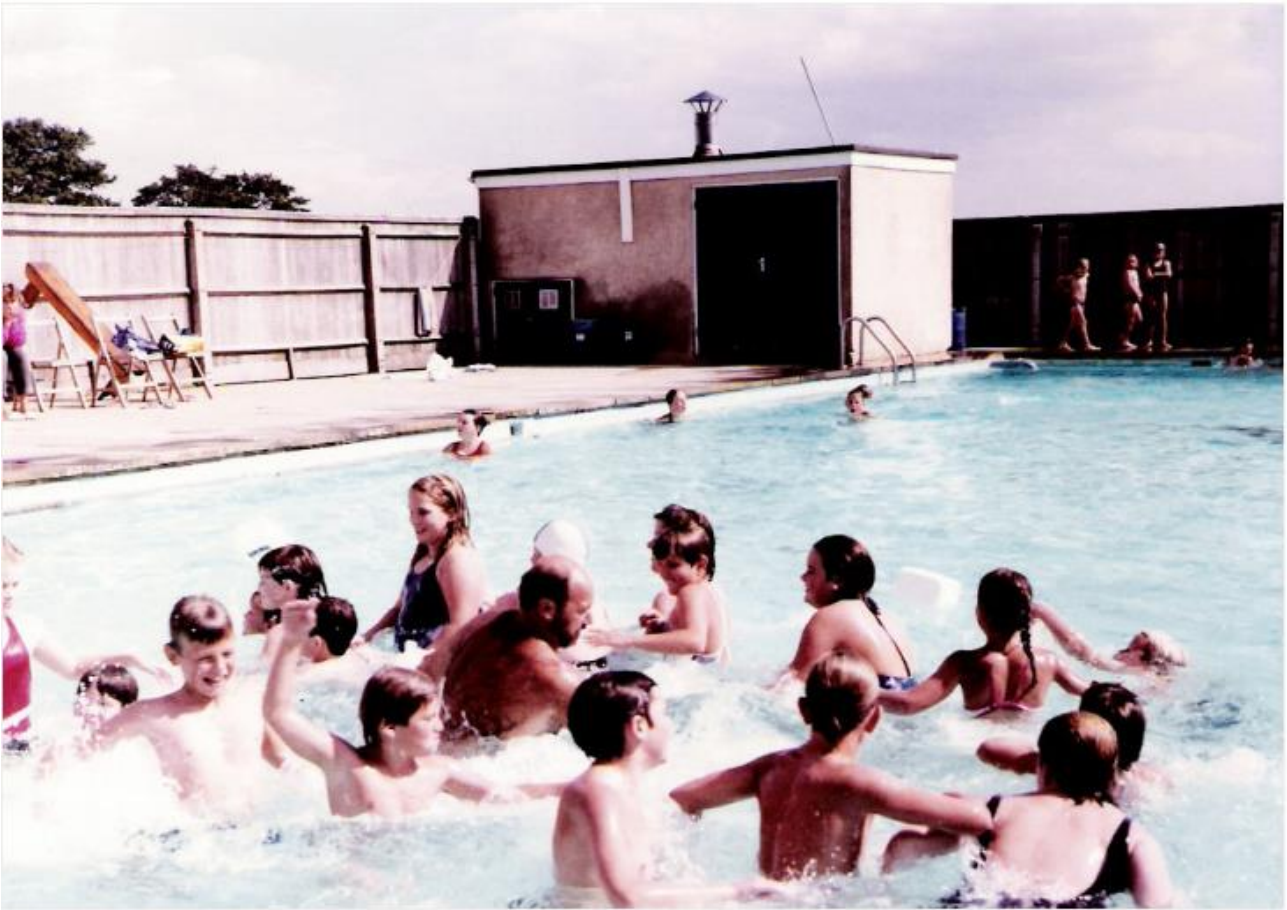
Photo 4: Historical photo 1980s showing the plantroom in the background. For more historical photo refer to Galley & Pool Historical in link <http://www.overtonswim.org.uk/community/lordsfield-swimming-club-6047/home/>

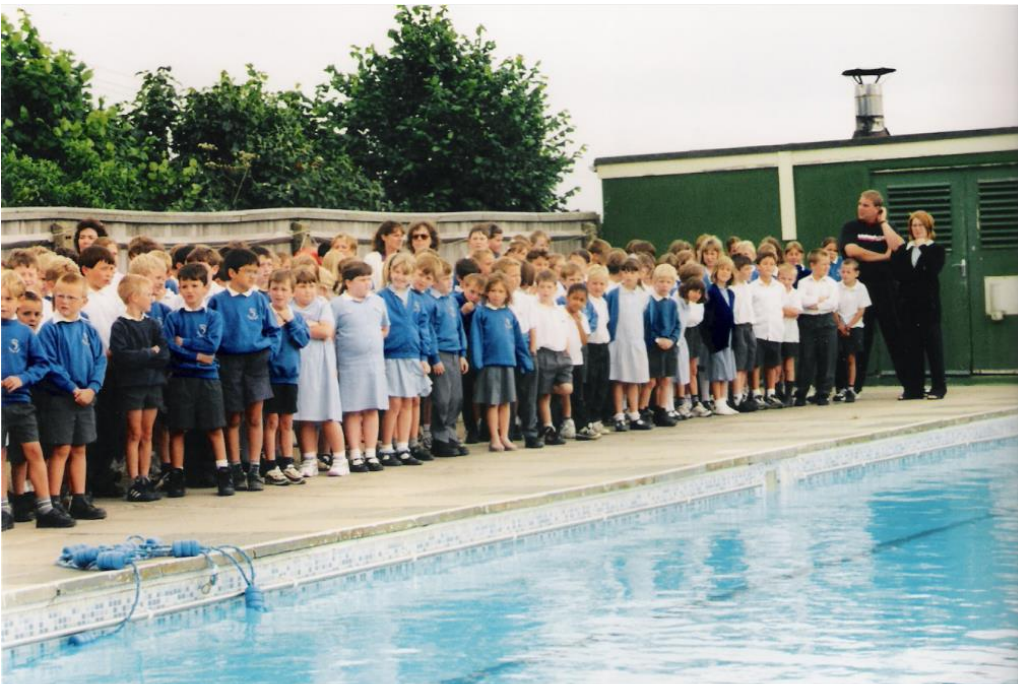
Photo 5: Historical photo 1990s showing the plantroom in the background and pool lining remains. For more historical photo refer to Galley & Pool Historical in link <http://www.overtonswim.org.uk/community/lordsfield->
